POLO & ASSOCIATES HOME INSPECTIONS, LLC

*Survey Abstract (*Summary of Concerns*)

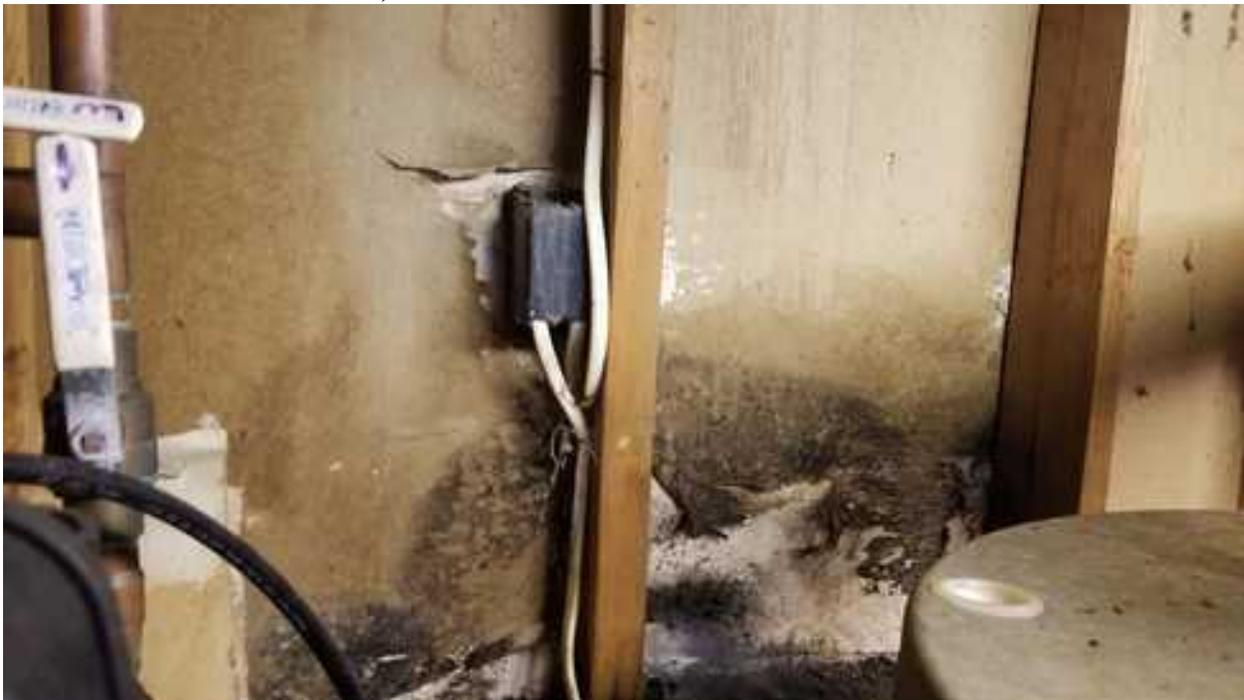
[1C.50](#) Instability/settling indicators & phenomena: common floors uneven/not level; insect damage, rot, light/inappropriate framing, etc. possible; sag/settling/shrinkage/partitions offset from structure below possible

[1C.18](#) Structure/foundation moisture indicators and phenomena: Painted walls/floors may be concealing possible deterioration or chronic water intrusion conditions, termite mud tunnels, etc. Consult sellers as to any moisture/insect issues; moisture in finished basement walls (moisture metered); water damage found from flooding according to seller; efflorescence; moisture penetration from outside through foundation wall; mold like substance; stains visible in basement

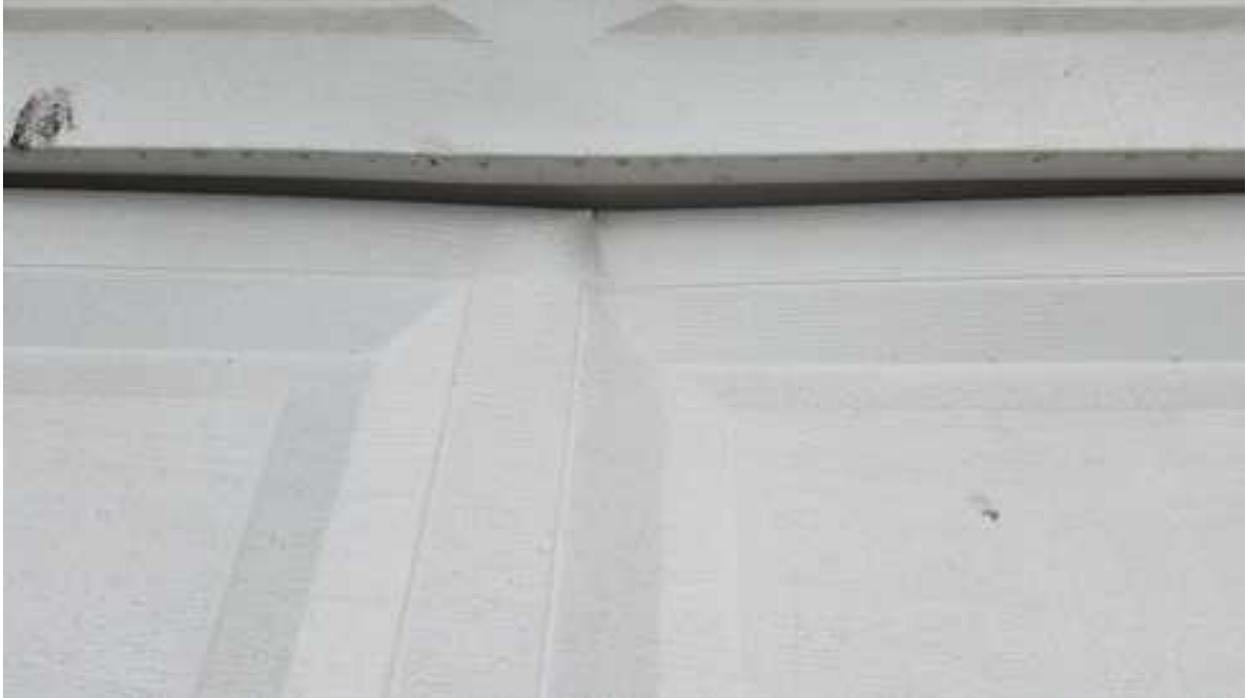
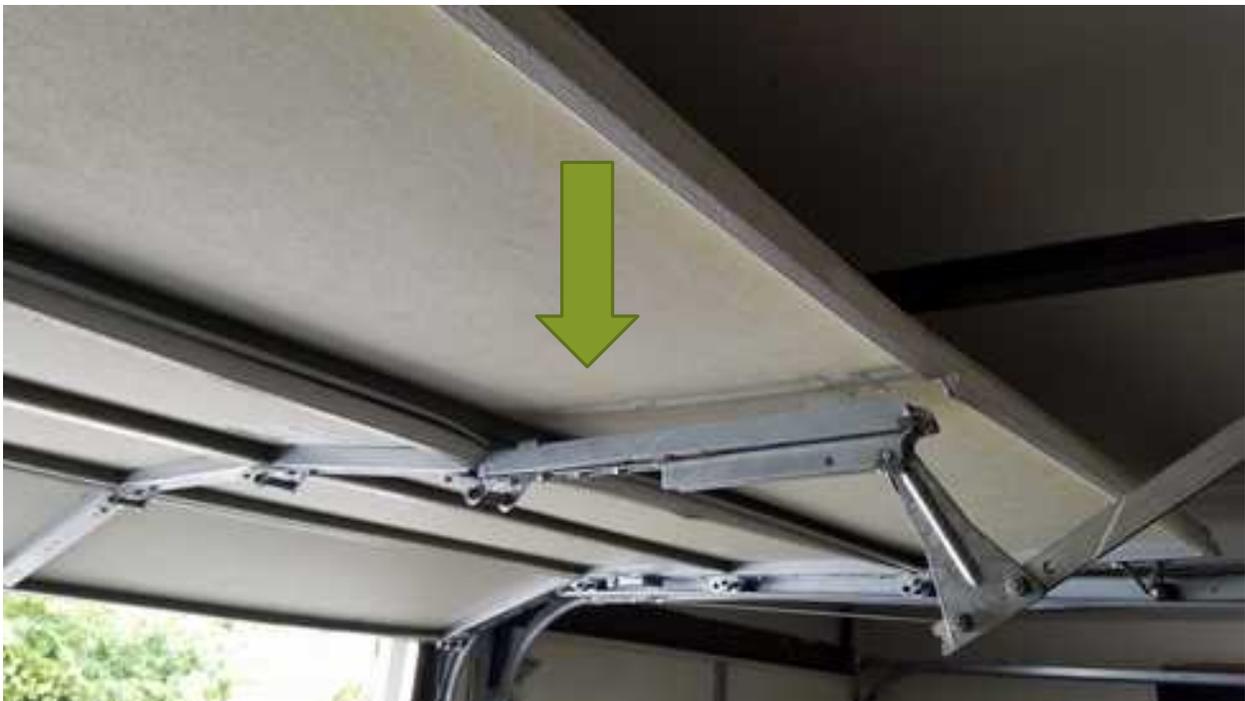
Garage door should have safety sensors for safety

[7C.08](#) Garage doors are damaged. Recommendation: Repair or replace and Assess safeties prior to further use. This is a safety concern. This is an expense concern

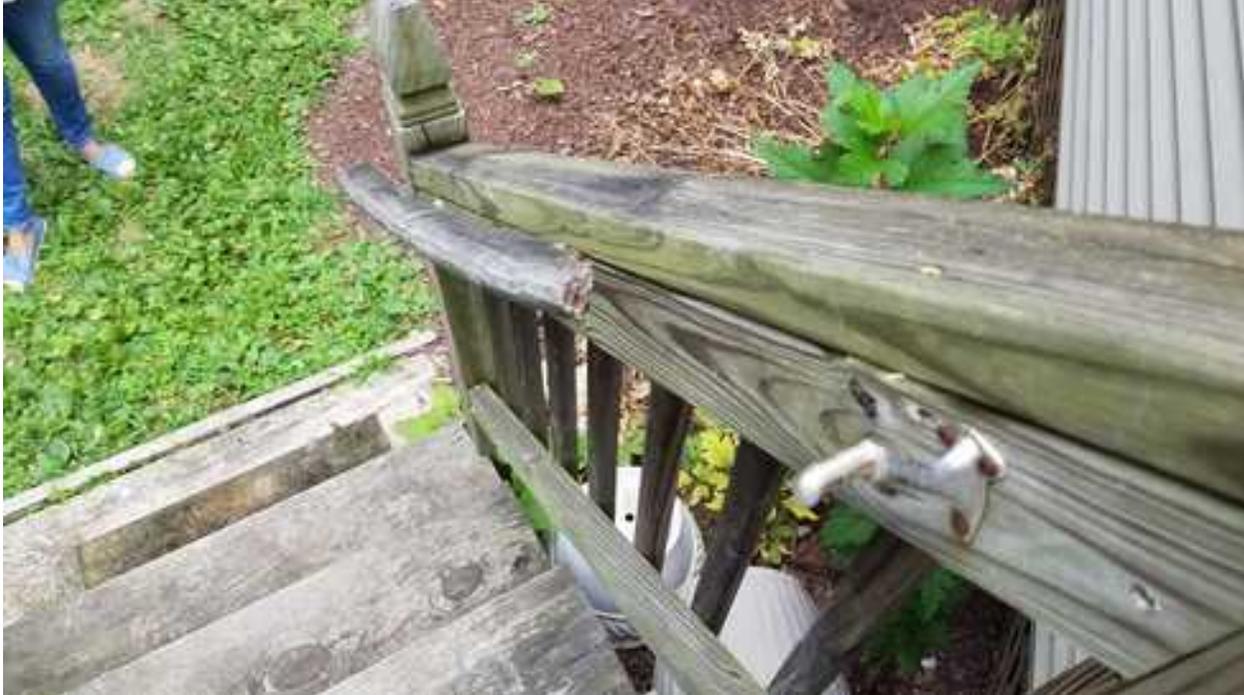
Balusters should be doubled screwed both top and bottom on railings for safety at the rear

- [2C.03](#) Guardrails are loose (unsteady support). Bolt posts properly/replace as needed for the deck. This is a safety concern. This is an expense concern
- [2C.03](#) Guardrail: Sphere of 4" diameter could pass through balusters. Repair is recommended with smaller openings for safety
- [2C.04](#) Handrails rotten/missing and needed where steps have 3 or more risers. This is a safety concern for the deck. Recommendation: Replace

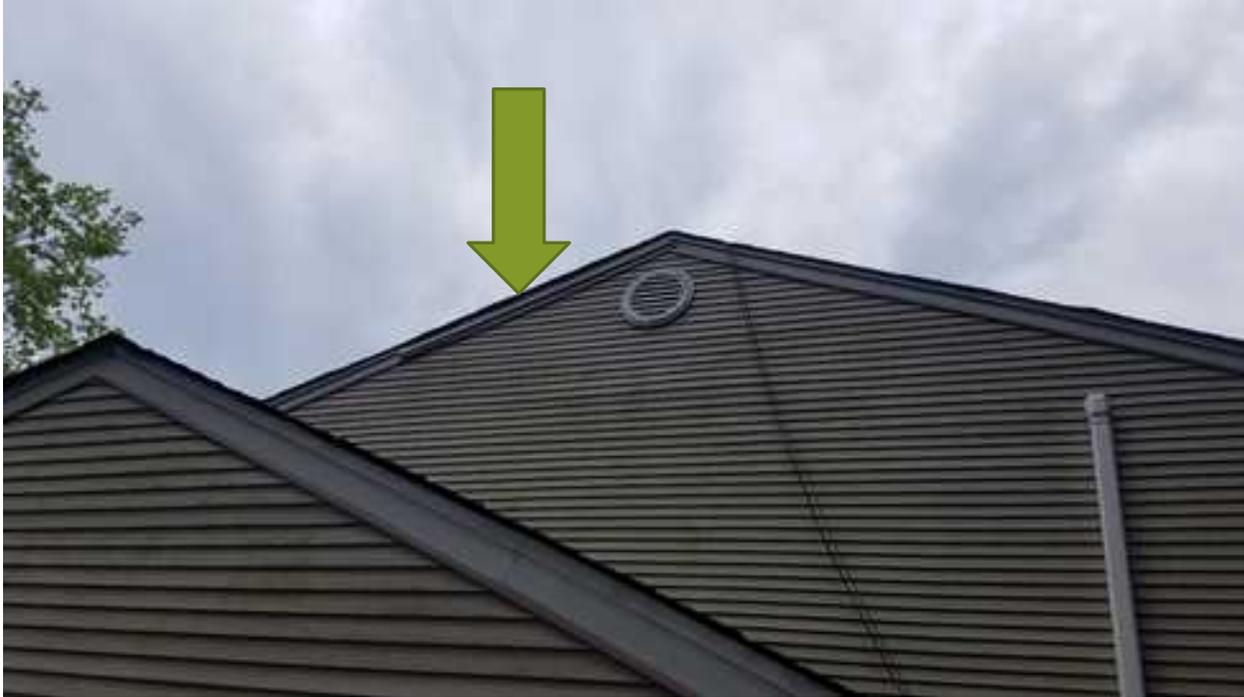
- [2C.02](#) Aluminum wrapping is loose/damaged/improperly installed in areas and recommended for all exterior wood trim for protection from the elements and to prevent damage and intrusion

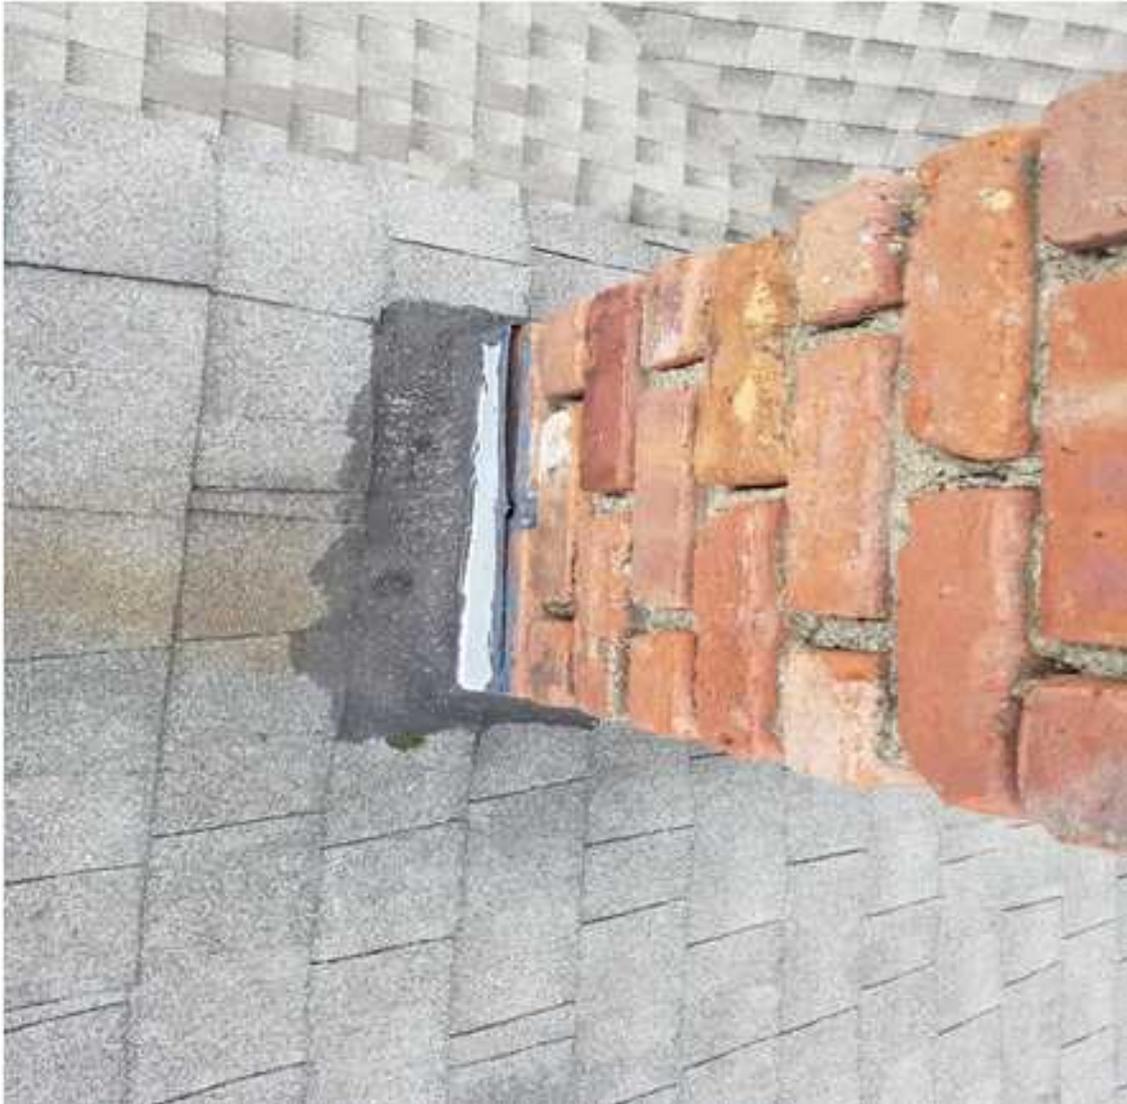
Sealer on chimney/masonry is recommended to repel moisture. Sealer must be “vapor permeable” ONLY so as not to trap moisture and deteriorate structure. This is a safety concern

[1B.04](#) Chimney crown/top area should extend at least 1 1/2” beyond chimney to properly shed water and prevent chimney damage. Repair/replace is recommended to stop/prevent water intrusion. This is a safety concern

[2C.18](#) Counter flashing on chimney is loose. Repair is recommended to prevent leaking

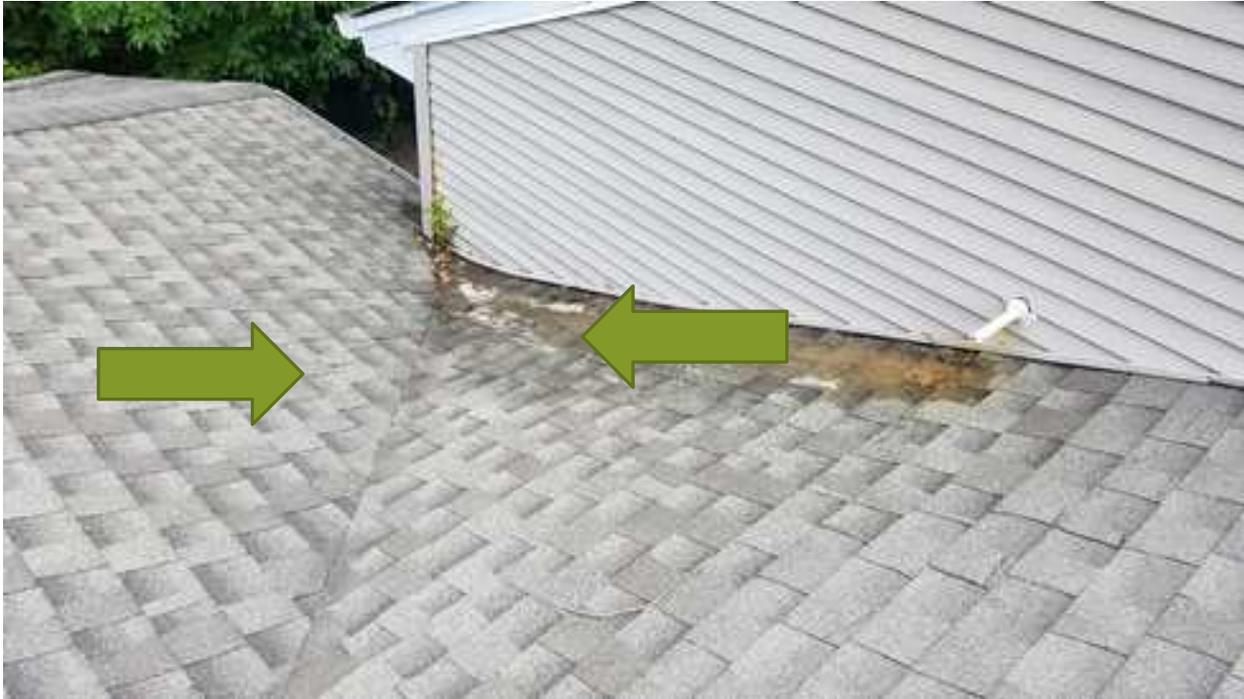
Decking is loose, not properly fastened, weathered, etc. and must be secured to structure for safety. Repair is recommended

Kick out flashing is needed at all wall and roof intersection and a water-proofing membrane beneath the shingles where addition joins dwelling to stop water damage and leaking. This is a safety concern. This is an expense concern

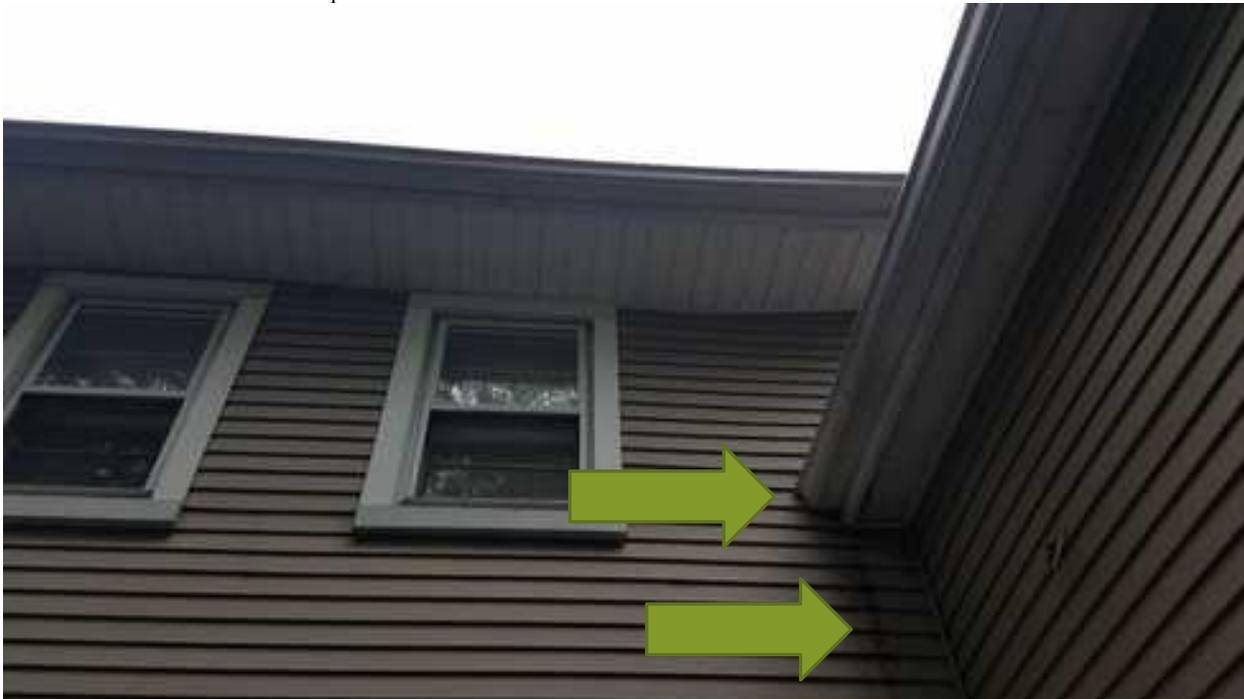
[2C.19](#) Vinyl/aluminum wrapping, soffit and or siding loose/missing/damaged/bulging in many areas.

Recommendation: Repair or replace as needed and remove siding, gutter and roofing as needed to determine extent of water and condensate damage behind gutter, roofing and siding at the rear where addition joins dwelling. This is a safety concern. This is an expense concern

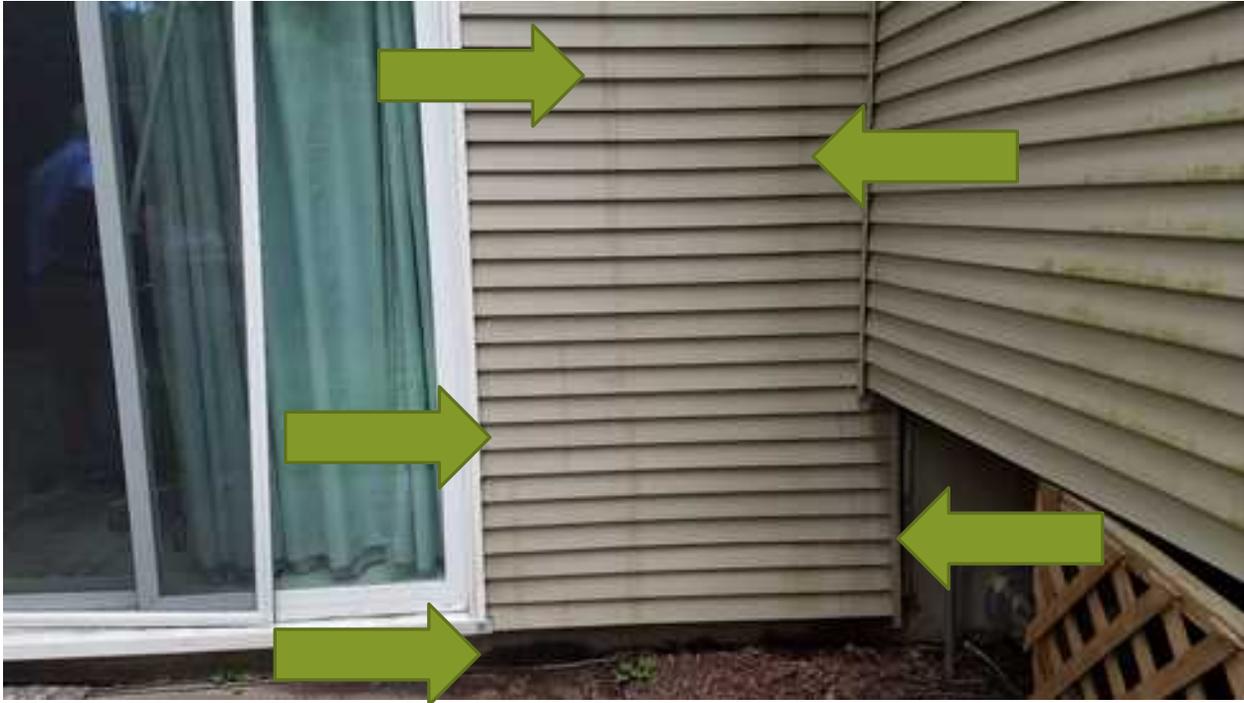
Vinyl siding deforming/melting (exceeded 160 degrees?) on the left side perhaps from outdoor grill, electrical malfunction (excessive heat) or other heat source that was too close or defective. Recommendation: Remove siding and assess. This is a safety concern

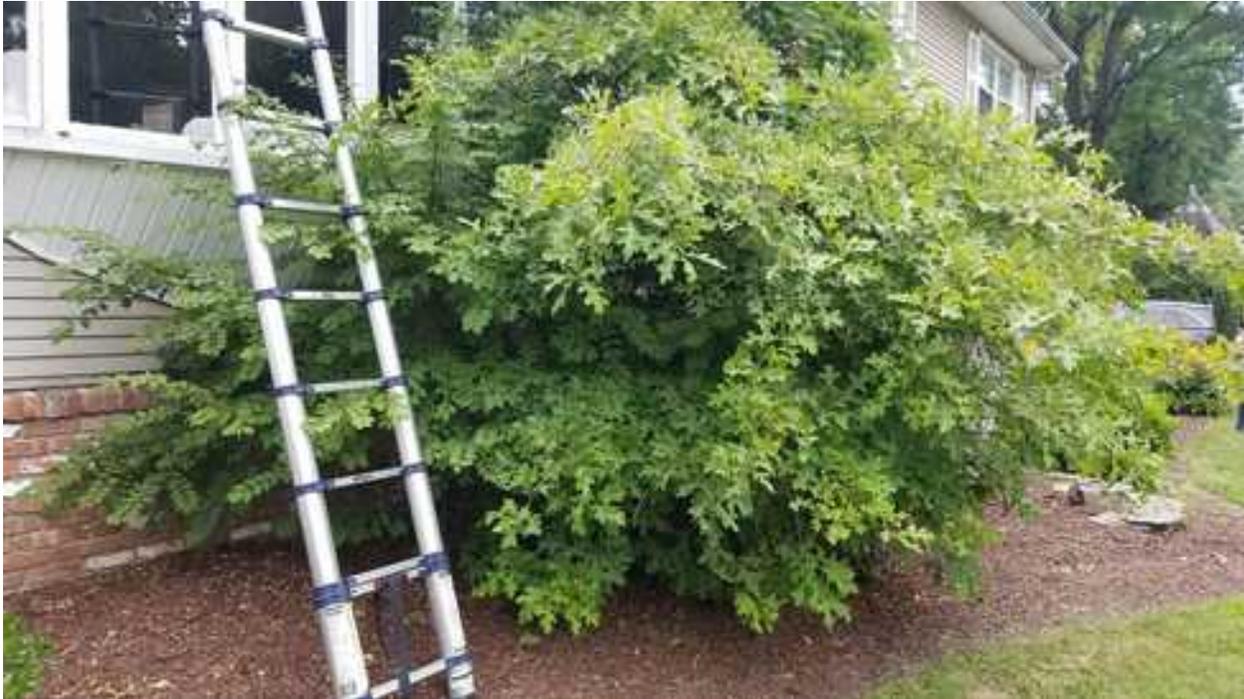
All "vegetation" with immediate detrimental effect on dwelling/garage should be fully assessed, managed and maintained for safety and proper function

- [1C.07](#) Wood deteriorating/deforming/moisture damaged beneath addition (soffit). Recommendation: Remove damaged panels, assess extent and cause of damage (animals, etc?) and replace. This is a safety concern

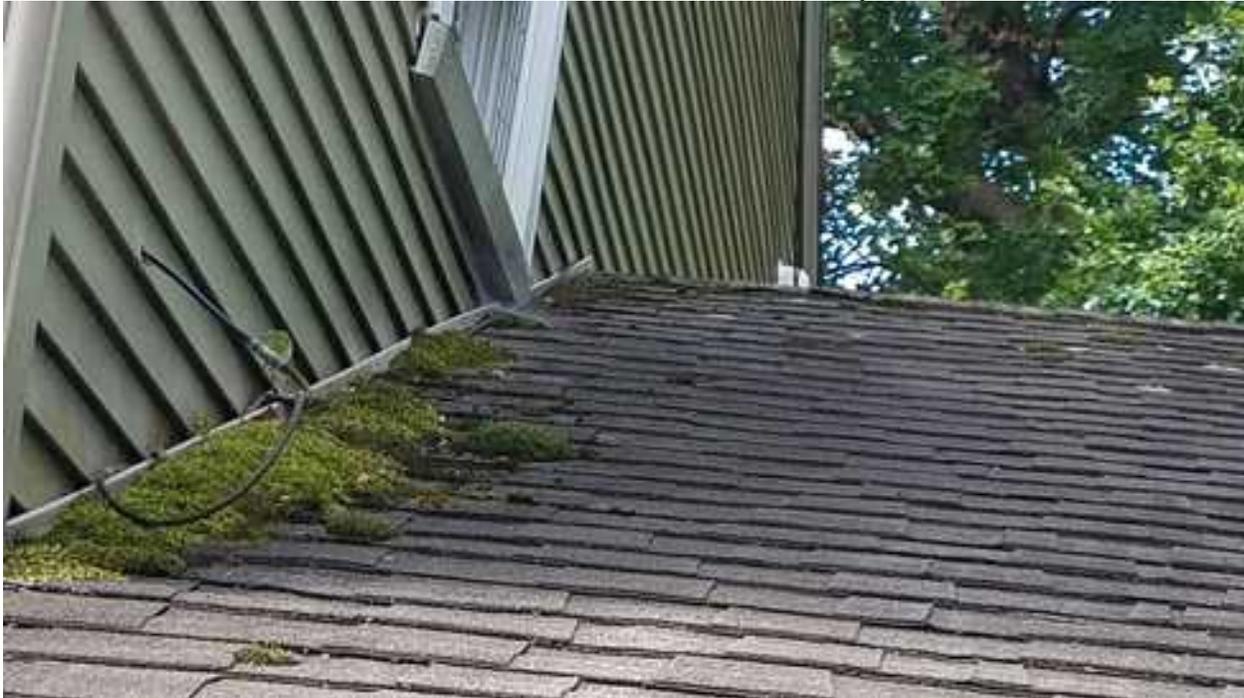
- [3C.06](#) Downspouts should extend further from house and terminate in open air to minimize water intrusion, settling, termite/pest infestation, etc
Commercial size gutters & downspouts are recommended (especially with steep pitches, valleys, etc.) to prevent heavy rains from caroming over gutters
Leaves, seeds/water in gutters; service now and periodically to prevent water intrusion, ice dams, mold, rot, insect damage, etc. The addition of a permanent, professional gutter guard system is recommended to control excessive gutter debris and minimize maintenance (but only if soffits are properly ventilated in order to prevent ice damming)
- [3C.25](#) Moss deteriorating roof: Professionally clean moss from roofs now to prevent further premature deterioration. Assess roofs when clean. This is an expensive concern

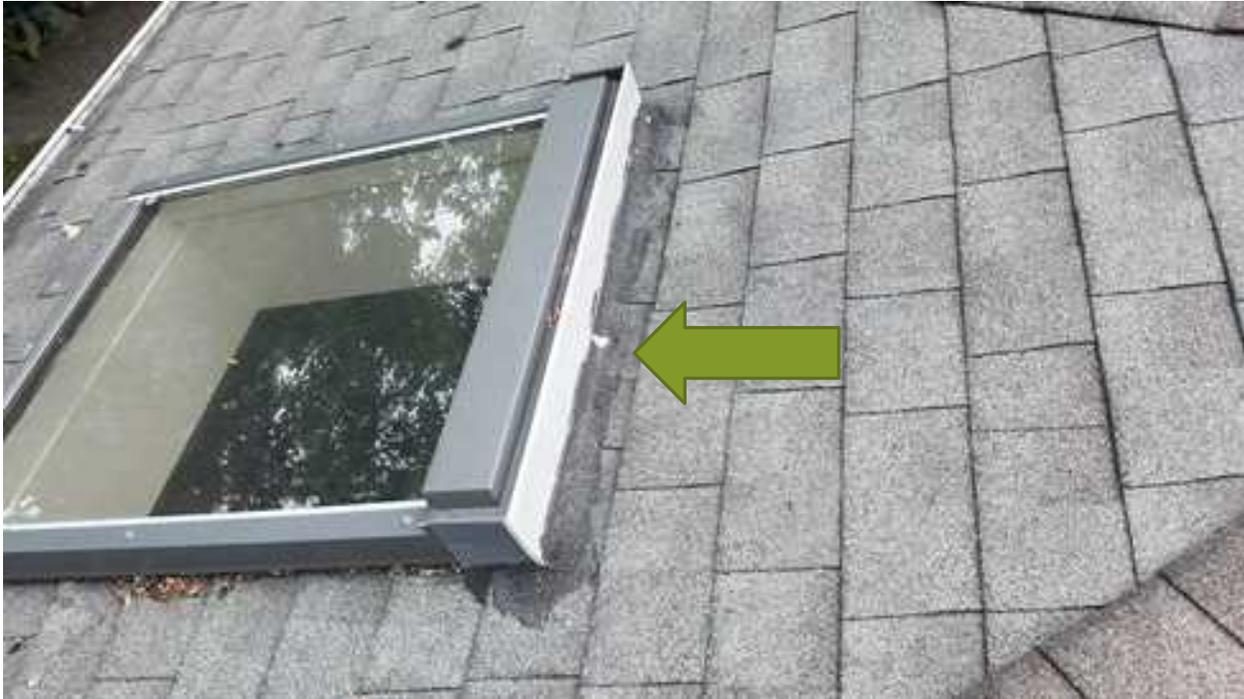
- [3C.12](#) Repairs with tar (temporary) on roof may indicate past or present leak: Consult with sellers as to why this is needed and service now & annually

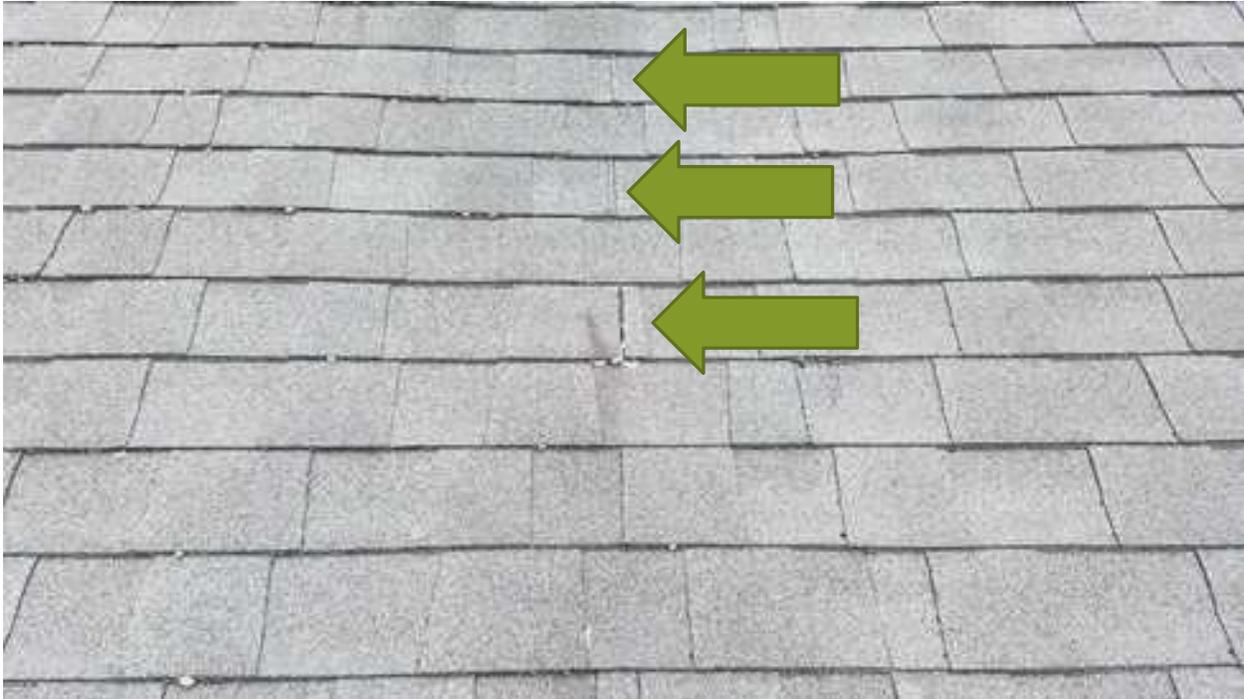
[3C.03](#) Shingles, asphalt: eroded/pitted/granules missing is consistent with the aging process of an older roof. Recommendation: Monitor, repair and budget for future functionality
Multiple layers and darker colors of roofing will adversely affect roofs longevity of require additional ventilation, etc
Dimensional shingles not “stepped up” according to manufacturer’s specifications (should have at least a 6” offset lap) may leak. Evaluation by a roofing specialist/shingle manufacturer is recommended

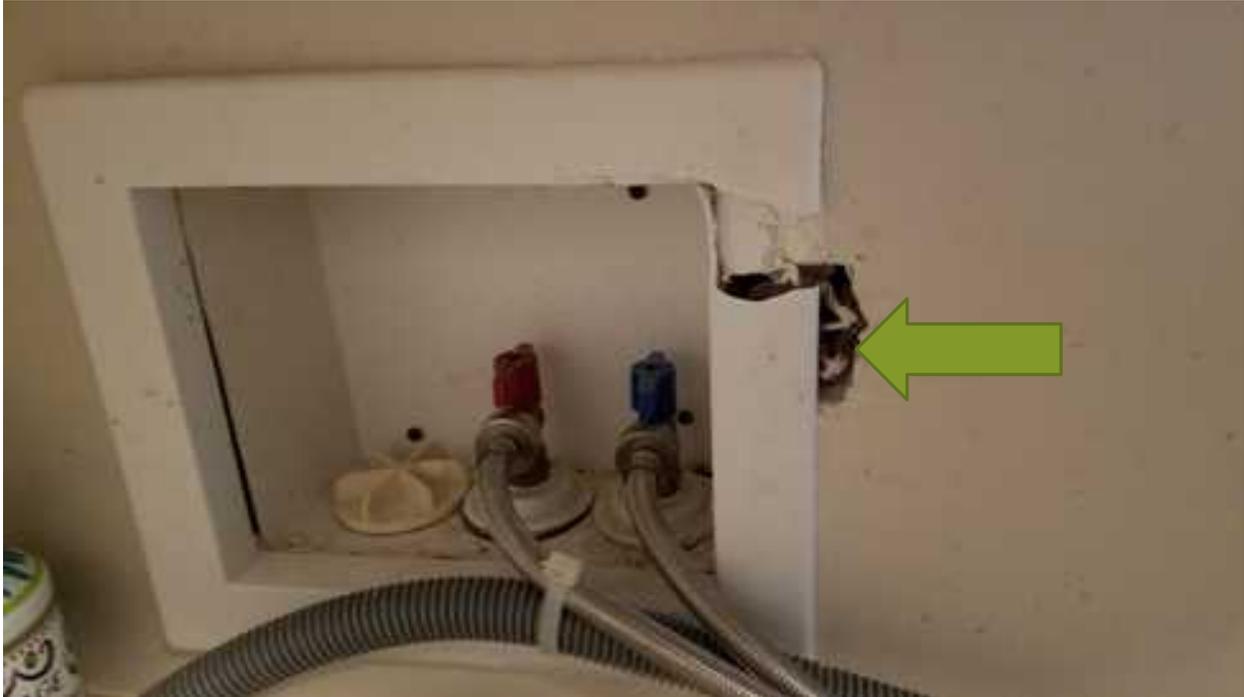
Shut off valve in laundry room (for hose?) is inaccessible. This is a safety concern. Repair is recommended

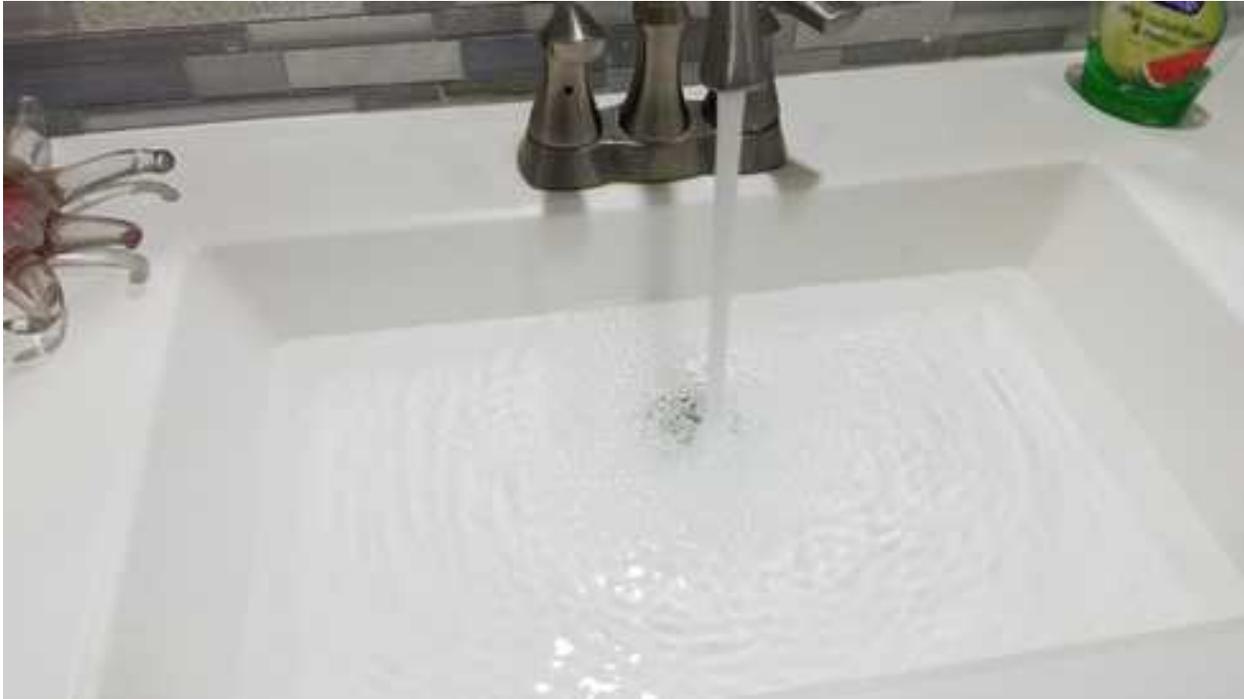
Sink stoppers not working/missing/may not be properly adjusted for proper drainage.

Recommendation: Repair or replace for bathroom sinks (slow drains) then assess drainage function

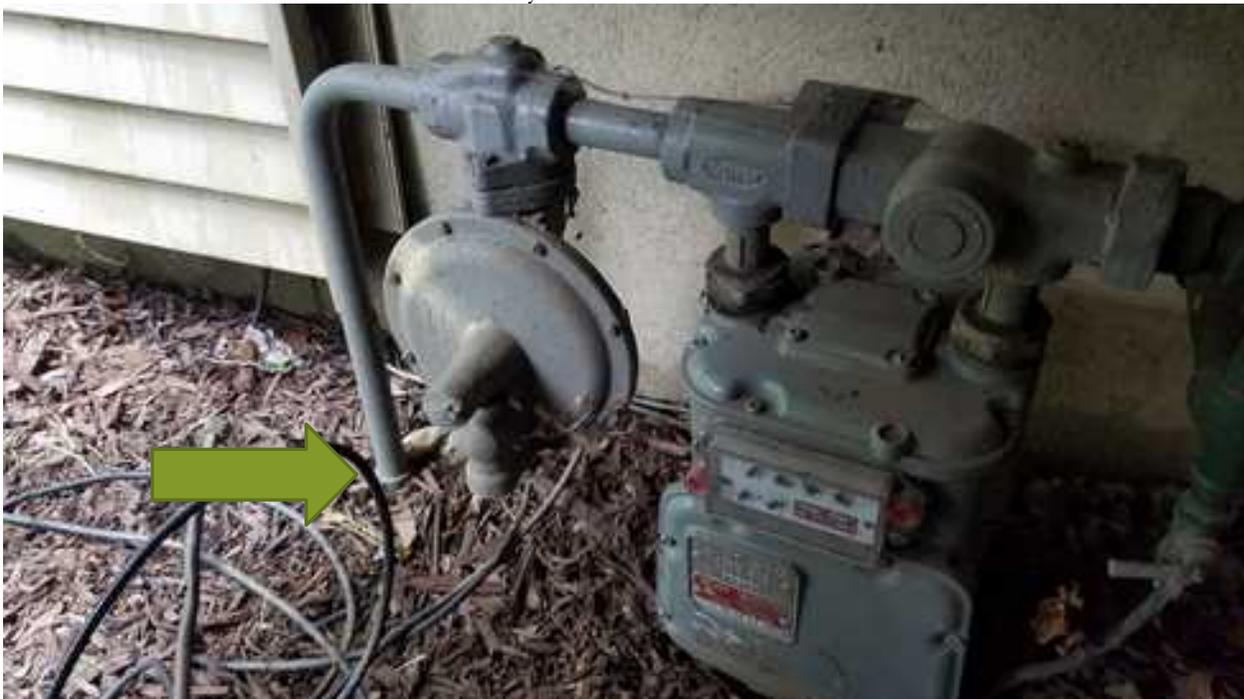
Gas shut off MAIN is missing/buried outside at the rear. Dig up and provide immediate access to shut off. This is a safety concern

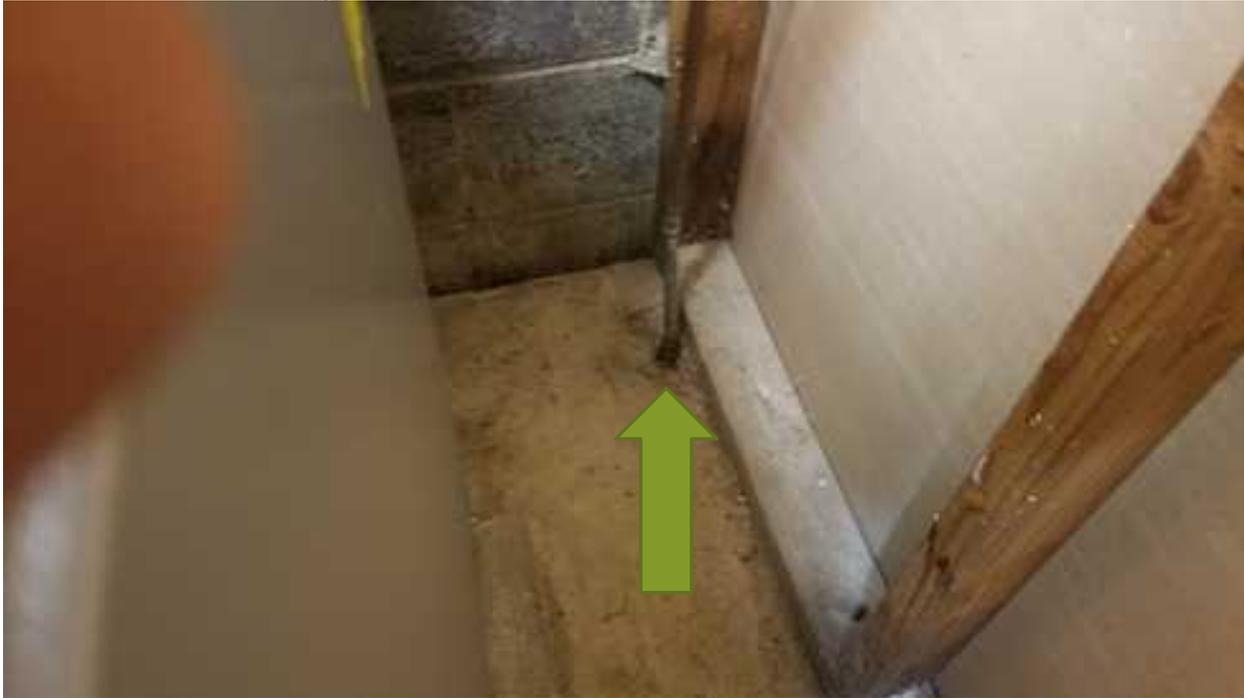
[4C.21](#) Copper piping/old shut offs seen in the basement with green/white staining may: have pin holes present/be leaking; have low corrosive PH in water; elevated lead level, etc.
Recommendation: Test PH level and lead in water for health and replace where leaking for proper function

[4C.21](#) Deterioration can occur in copper piping that is in direct contact with concrete behind boiler. This is a potential expense concern. Recommendation: Monitor and budget for future functionality or repair

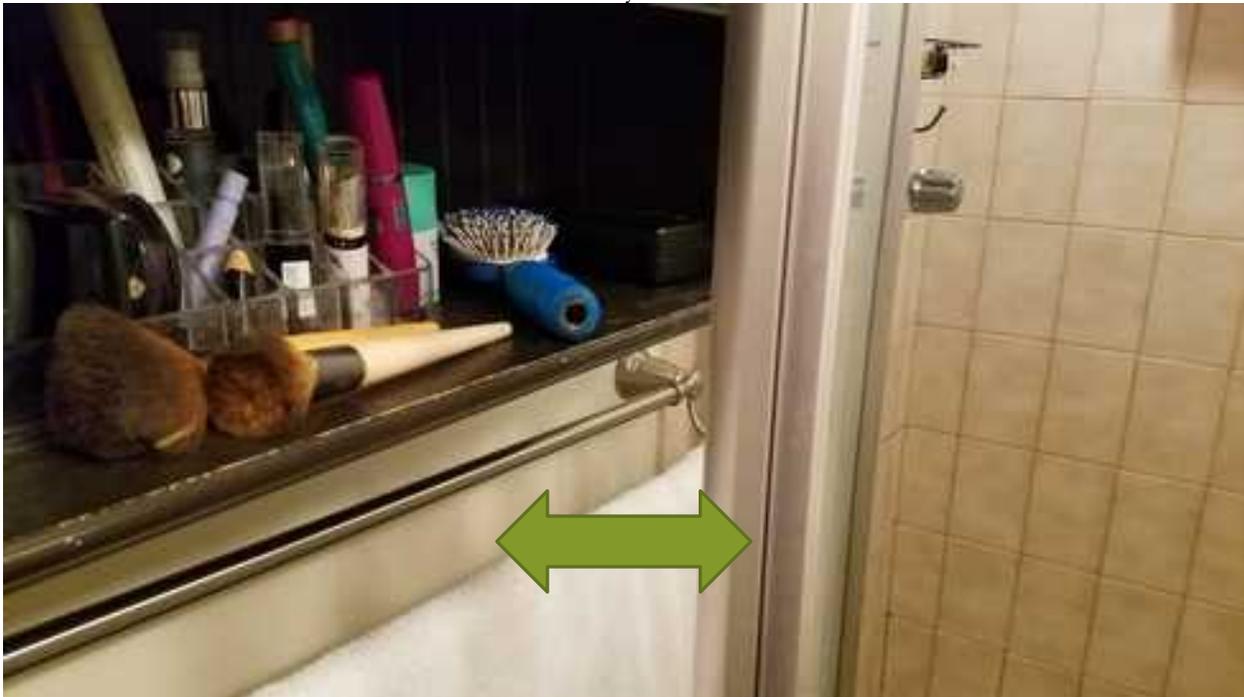
[8C.18](#) Shower door must swing outward to prevent entrapment and at least 90 degrees. Repair/replacement is recommended. This is a safety concern in the master bathroom

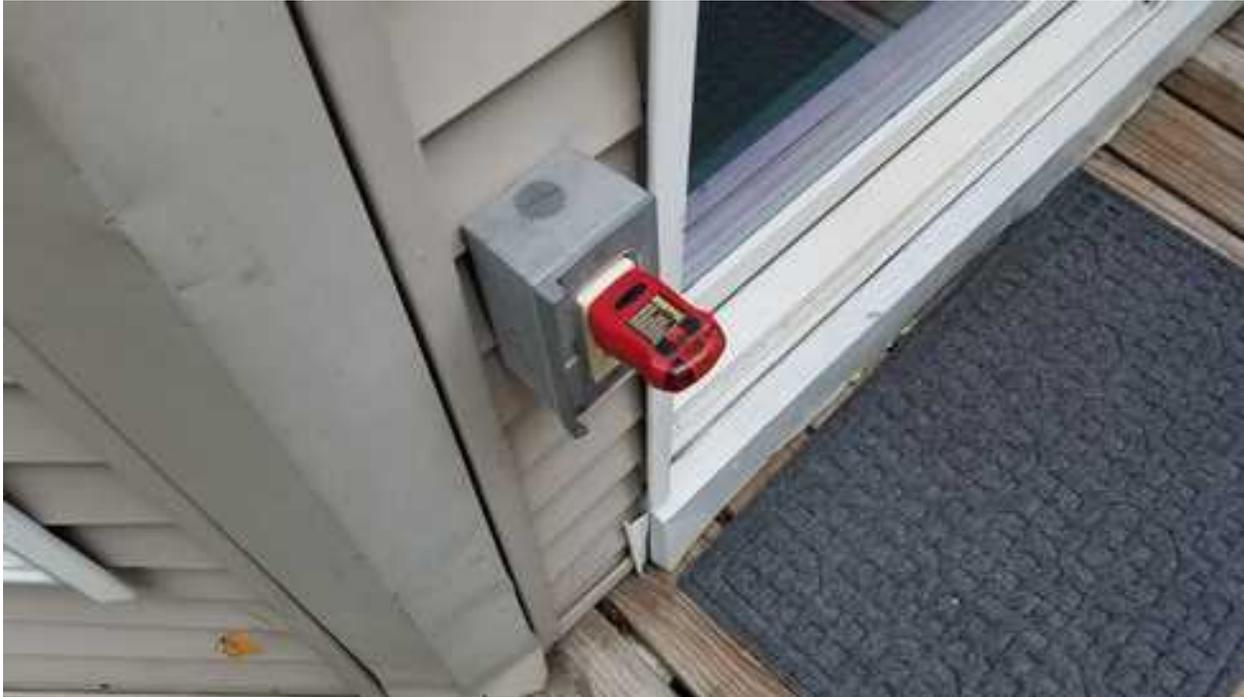
[5C.40](#) **GFI did not respond to test button and cover is broken off on the deck. Recommendation: Replace. This is a safety concern**

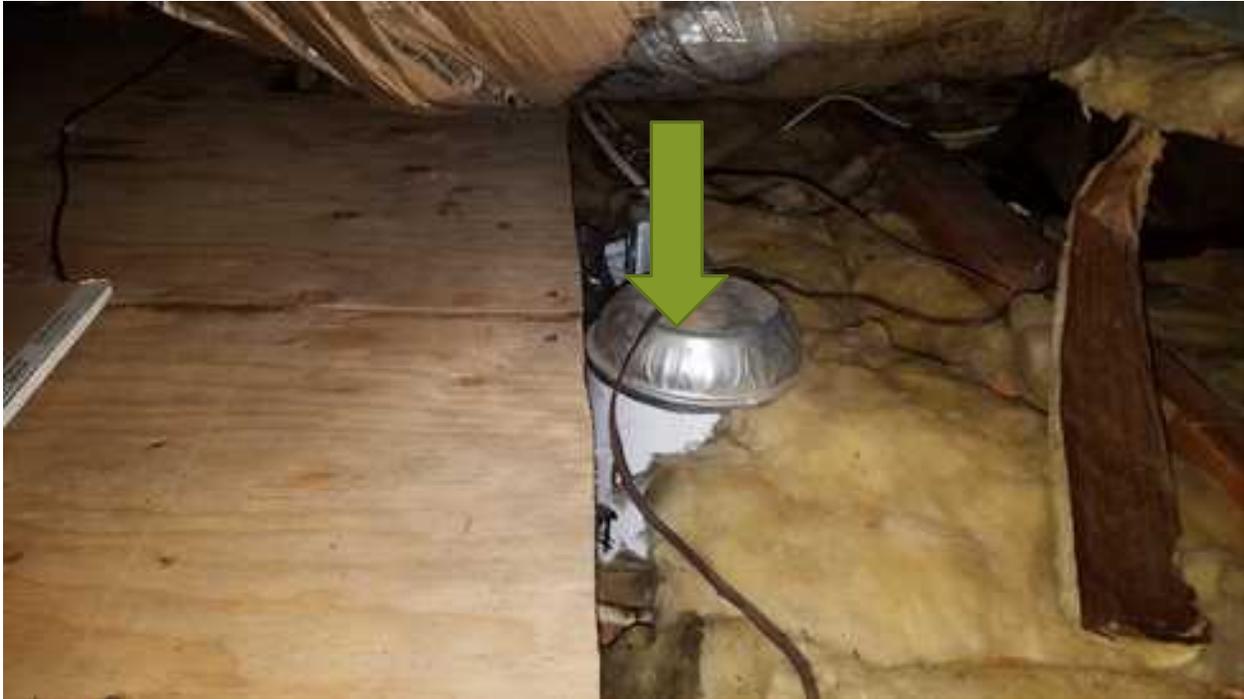
Recessed lighting does not appear to be IC rated (chrome finish not present) for material contact in the attic. Repair/replacement is recommended. This is a safety concern

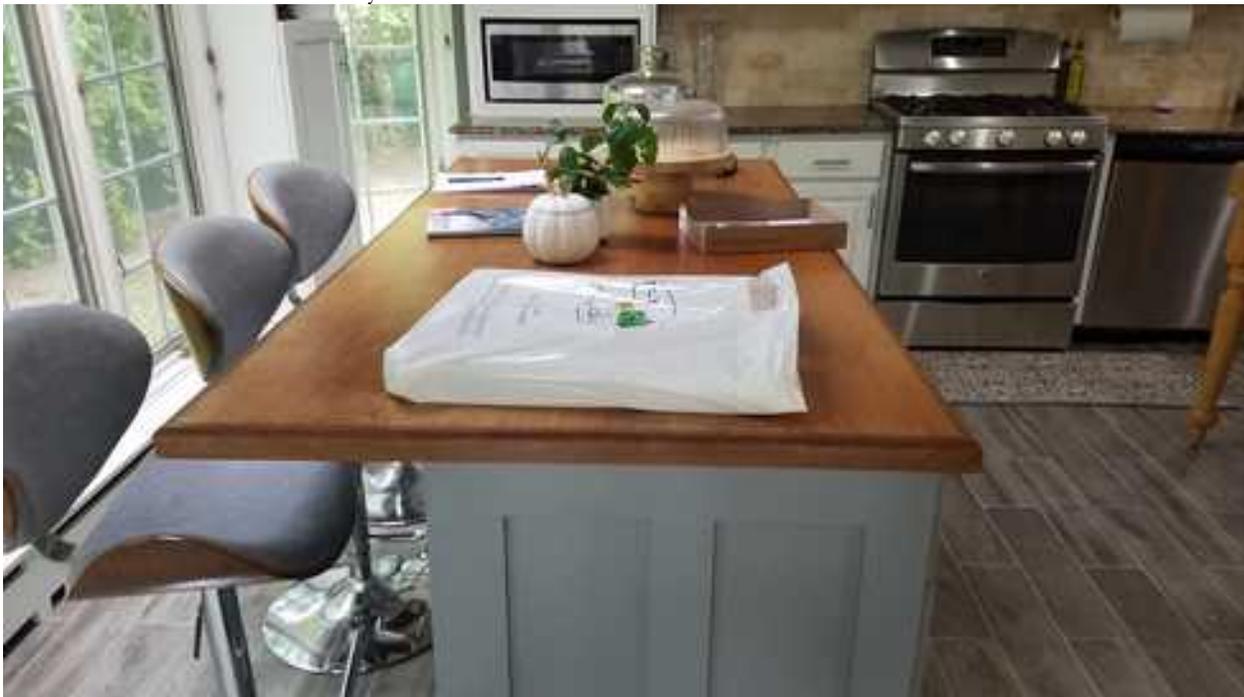
- [5C.77](#) Light fixture loose (hanging from wires)/broken outside at the rear. Recommendation: Replace
- [5C.07](#) Receptacles loose/not secured here and there. Repair is recommended. This is a safety concern
- [5C.60](#) Receptacle (gfcı protection) missing and recommend at kitchen island. Repair is recommended. This is a safety concern

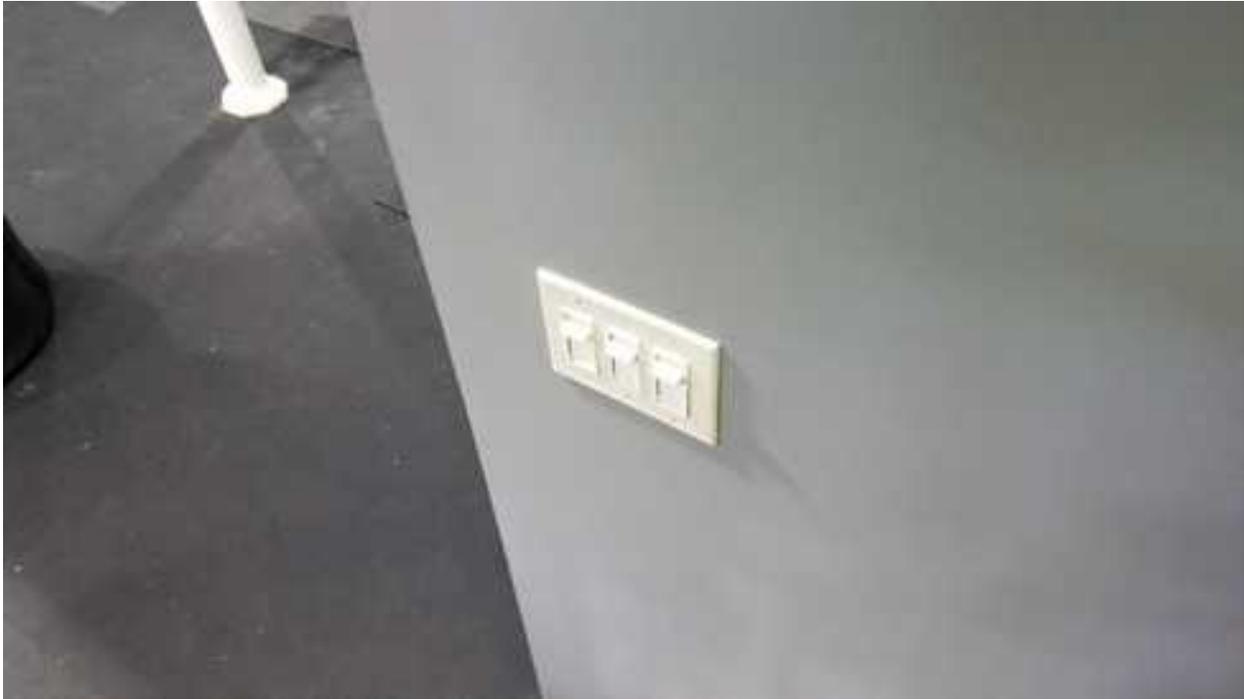
- [5C.30](#) Dimmer function is not working various areas: Switches likely incompatible with bulbs/bad switch/loose wire? Recommendation: Repair or replace as needed

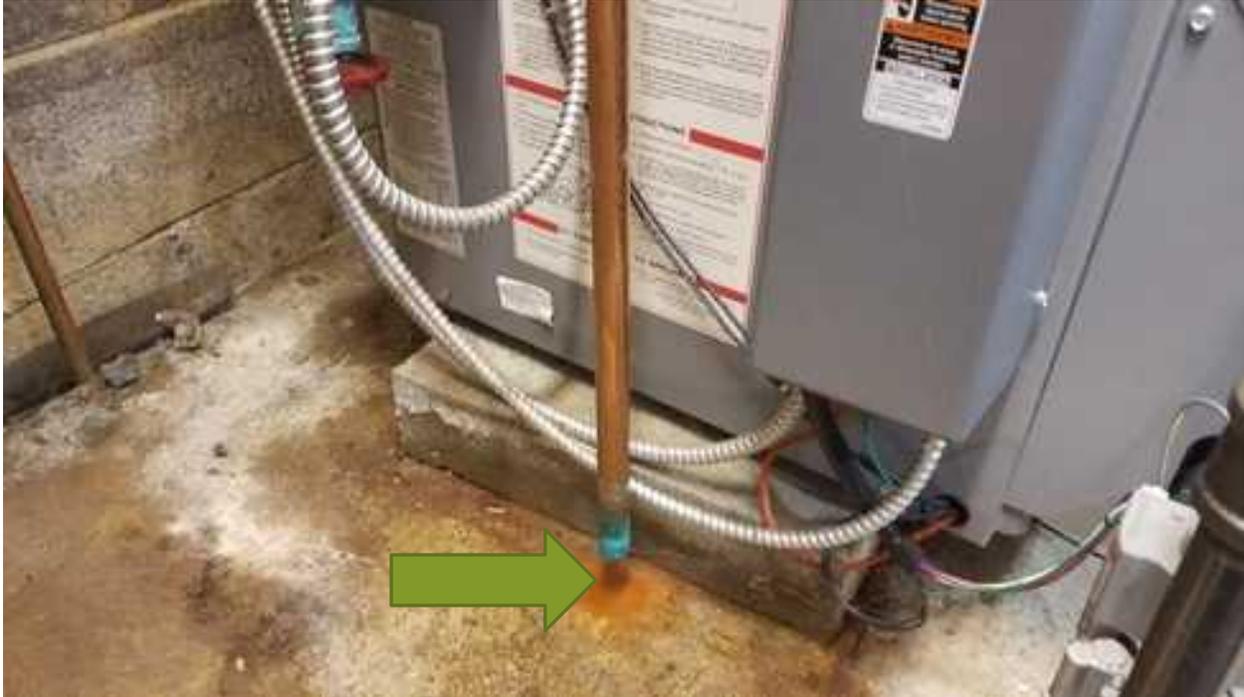
Pressure relief valve is discharging on boiler. Immediate evaluation by a heating contractor is needed ASAP. This is a safety concern
