POLO & ASSOCIATES HOME INSPECTIONS, LLC

*Survey Abstract (*Summary of Concerns*)

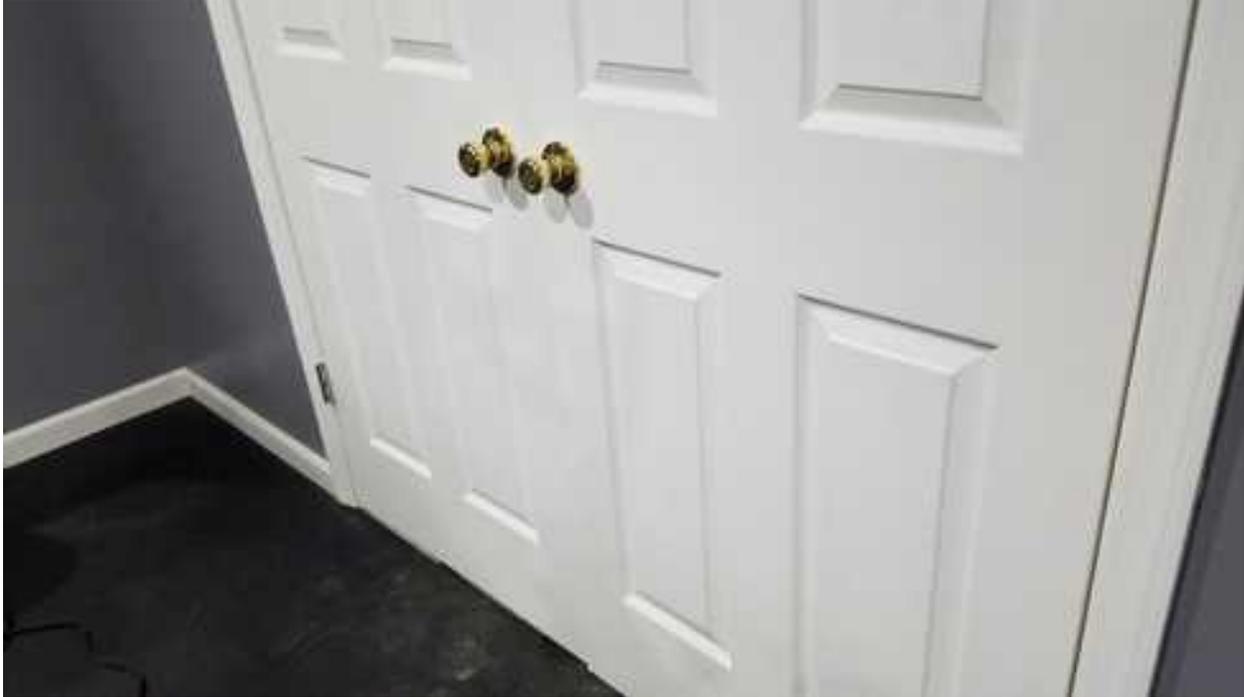
Make-up/combustion air source (12"x12" unobstructed oxygen source installed high and low at a minimum of unobstructed passage) is needed for boiler room for proper function and C/O safety

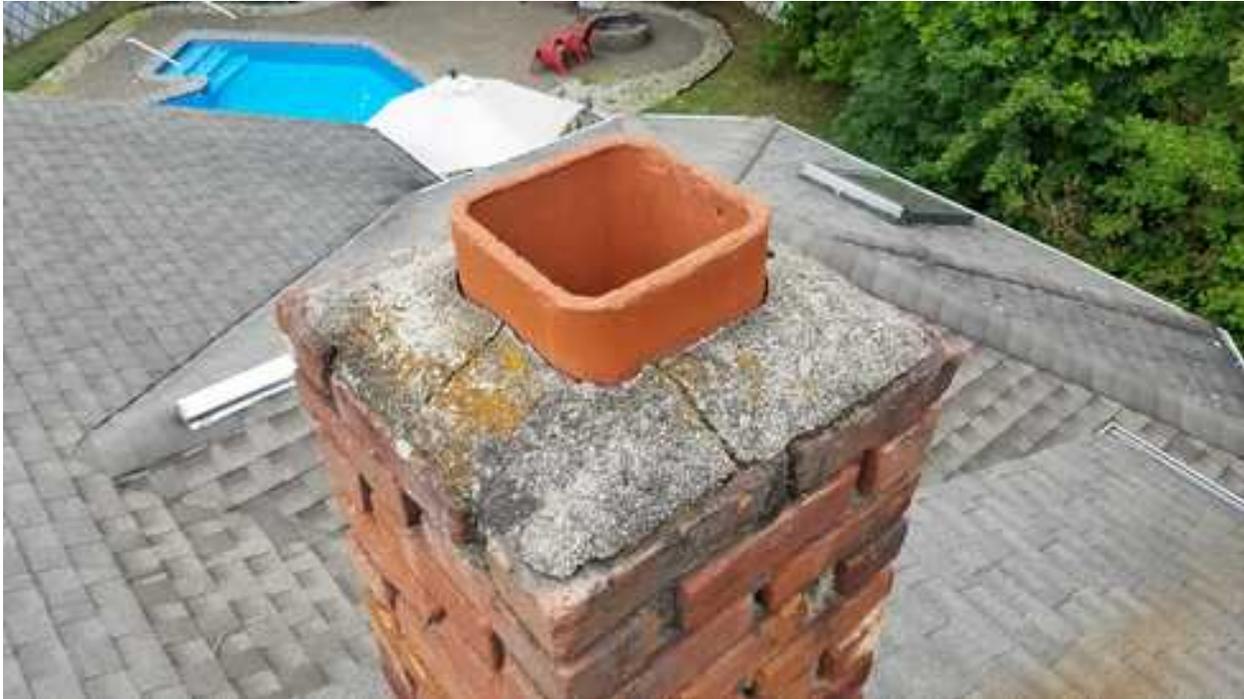
[6C.10](#) Flue/vent concerns: Stainless steel flue caps are needed for all flues/chimneys for safety and proper function

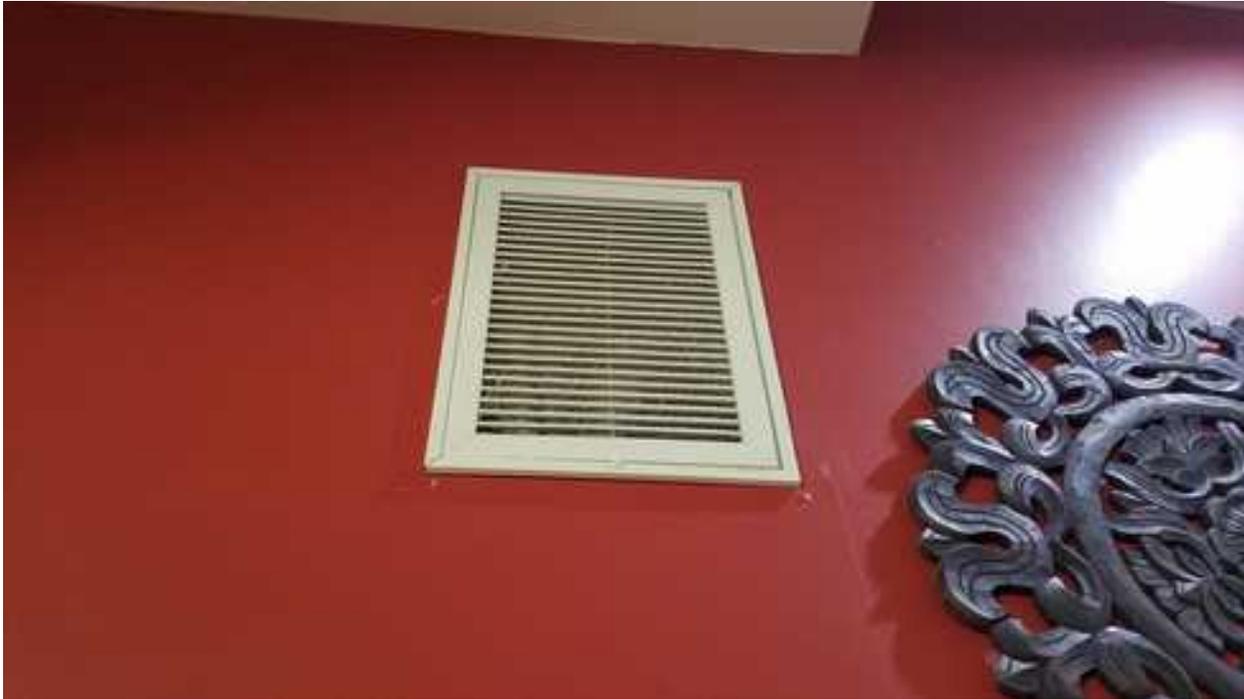
- [6C.06](#) A.C. condensate piping in the attic should be insulated to prevent sweating/freezing/water damage
Ample return ducts are needed on ALL levels that are conditioned by heat/A.C. for ample supply and function. Repair is recommended in the basement
Ducts (especially returns) and blower compartment may be in need of a PROFESSIONAL cleaning to remove dust, dirt, construction debris, dust mites, etc. This is a health and efficiency concern
- [6C.05](#) Air leaks from ductwork can lose up to 30% of heating and cooling efficiency so duct mastic is recommended to seal all connections for comfort and efficiency
- [6C.01](#) Filter dirty. Recommendation: Replace now and according to filters specifications

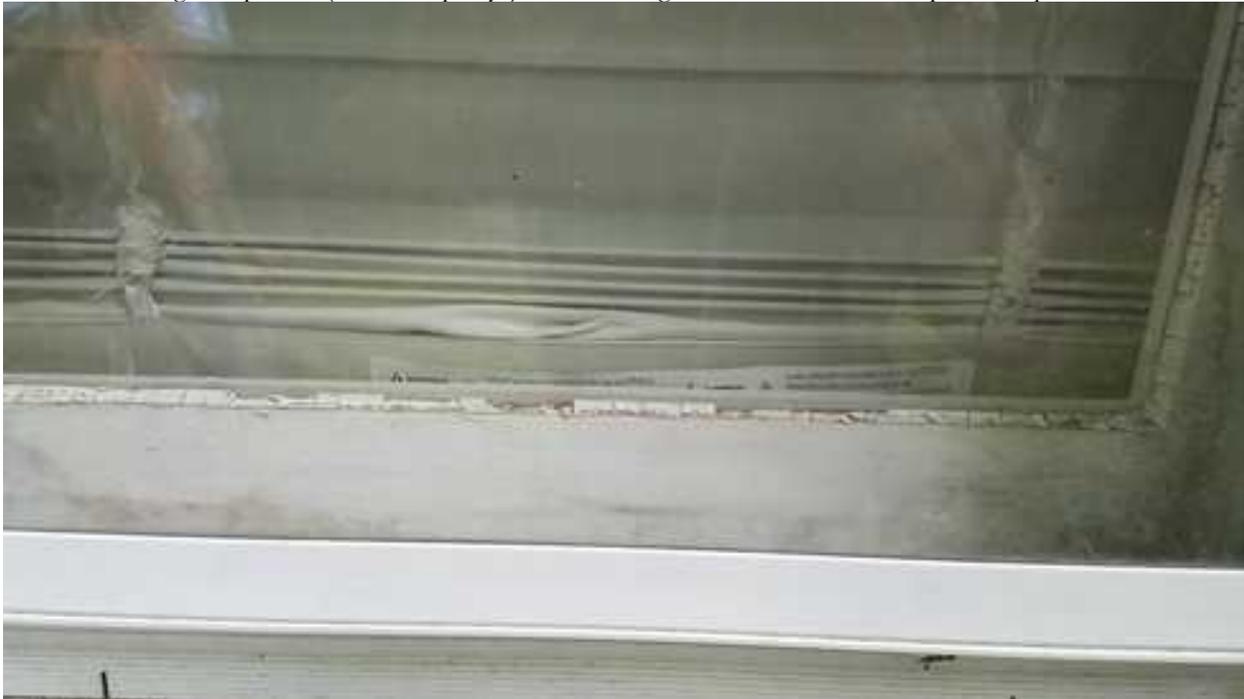
2C.01 Glazing compound (window "putty") deteriorating. Recommendation: Repair or replace

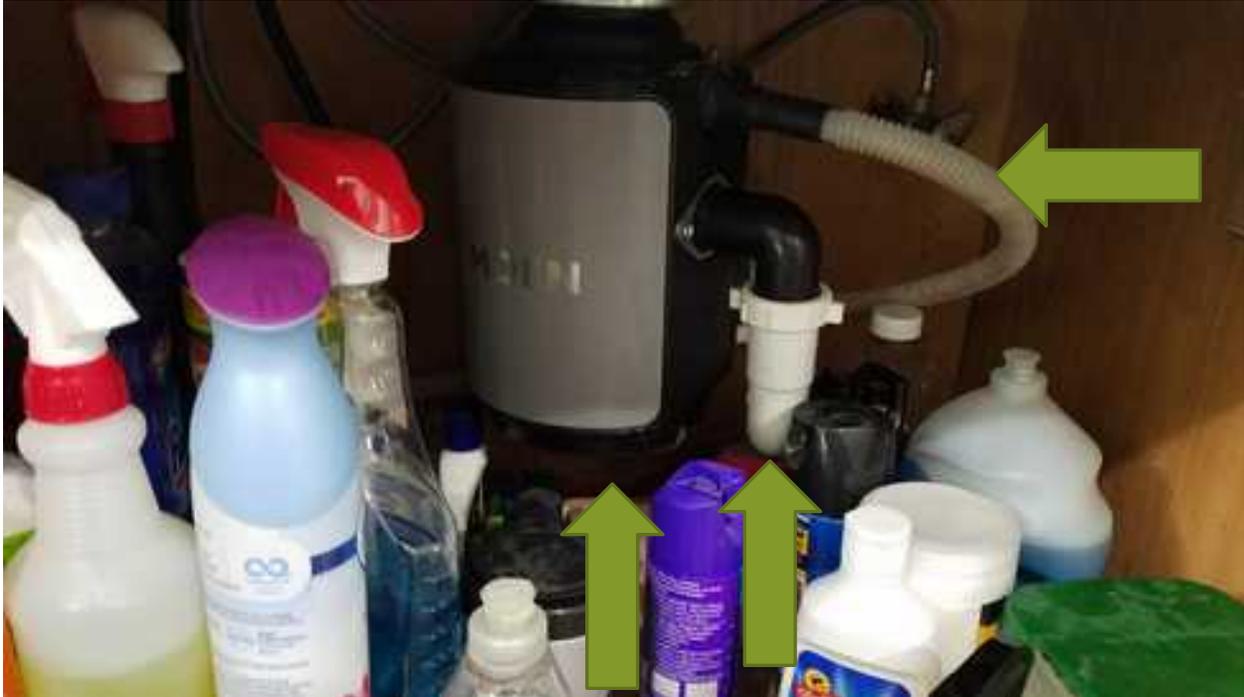
Disposal should be installed above bottom of trap for proper discharge. Repair is recommended

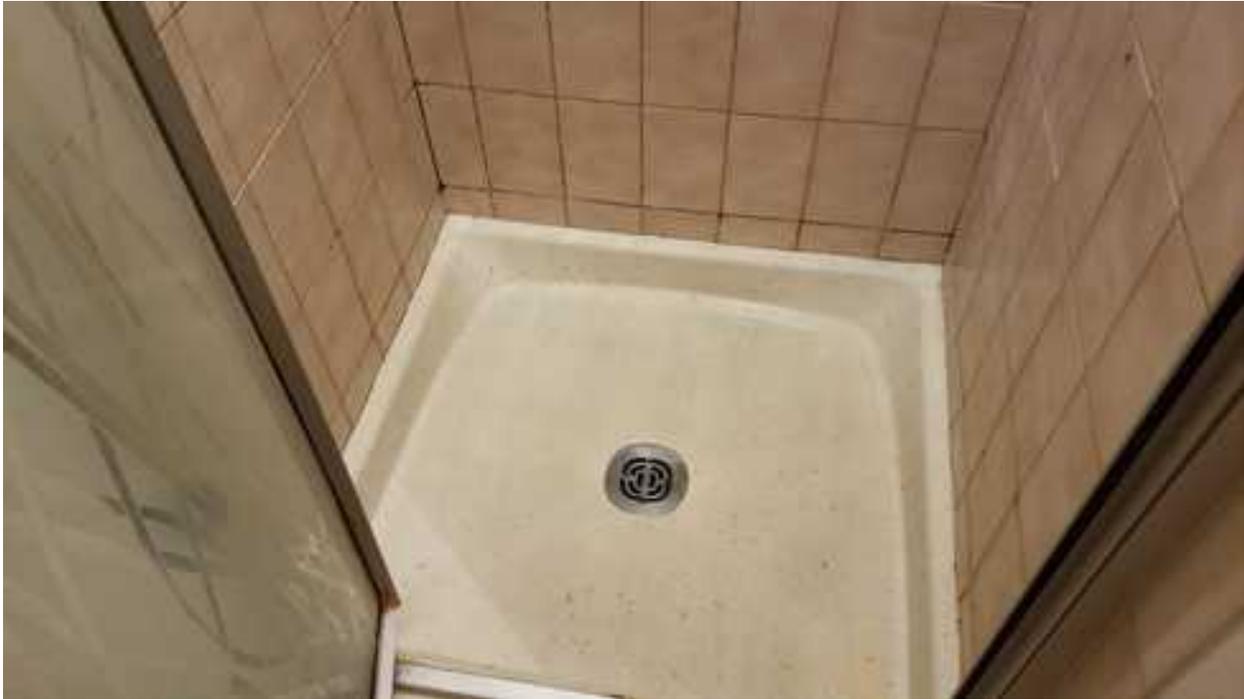
[8C.04](#) **Ceramic shower tiles not firmly attached in the master bathroom. Recommendation: Repair or replace. This is an expense concern**

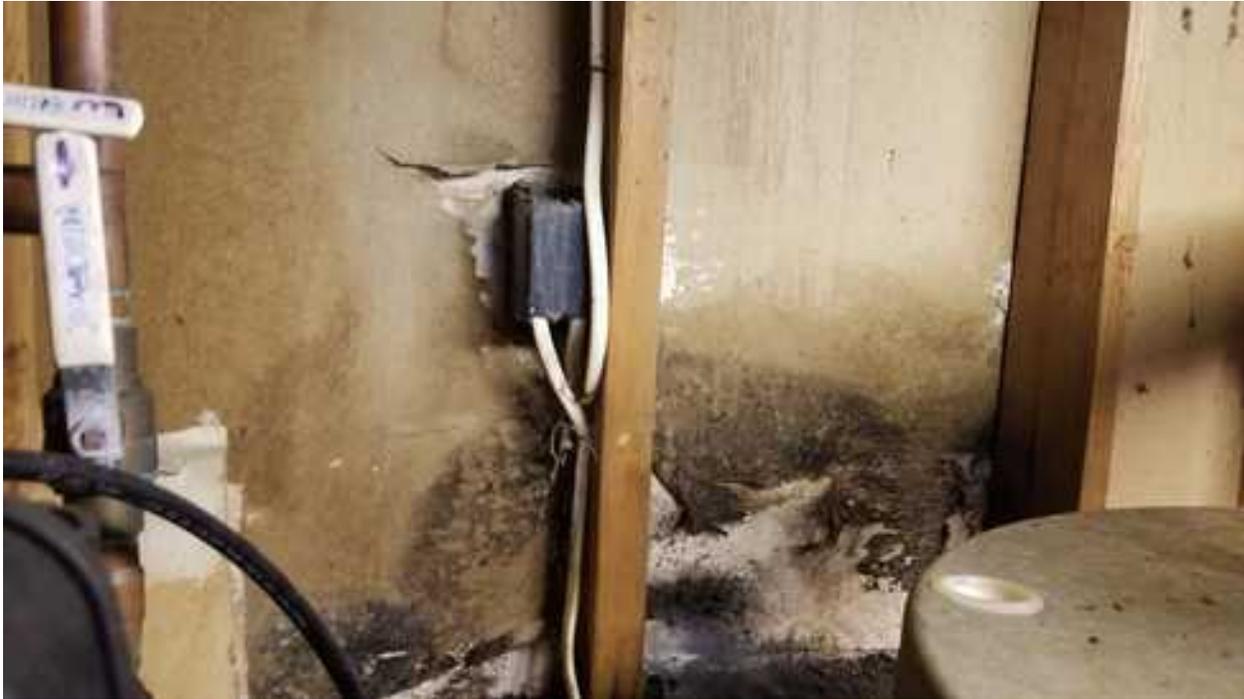
Mold/air: Mold is ubiquitous/everywhere and may or may not be seen, smelled or accessible therefore mold
testing is recommended. Call 973-539-0715 for testing prior to sale. This is a health
concern
