POLO & ASSOCIATES HOME INSPECTIONS, LLC

*Survey Abstract (*Summary of Concerns*)

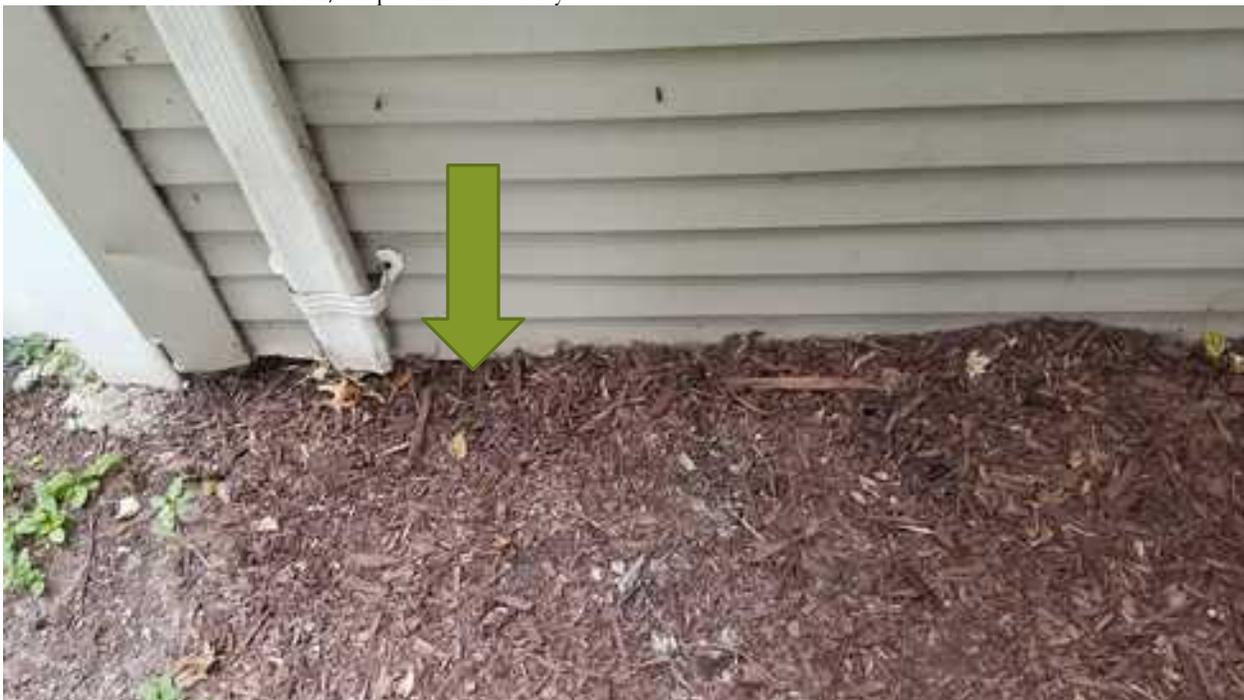
[2C.10](#) Wood: "First" wood untreated, too close to earth (8" or less) is prone to rot carpenter ant and especially termite damage as discussed. Repair/treatment is recommended to deter/stop termite activity
